Photo Documentation Report

Smith Residence

12489 Oak St N — Sioux Falls, SD 57104

Claim # CLM-44271

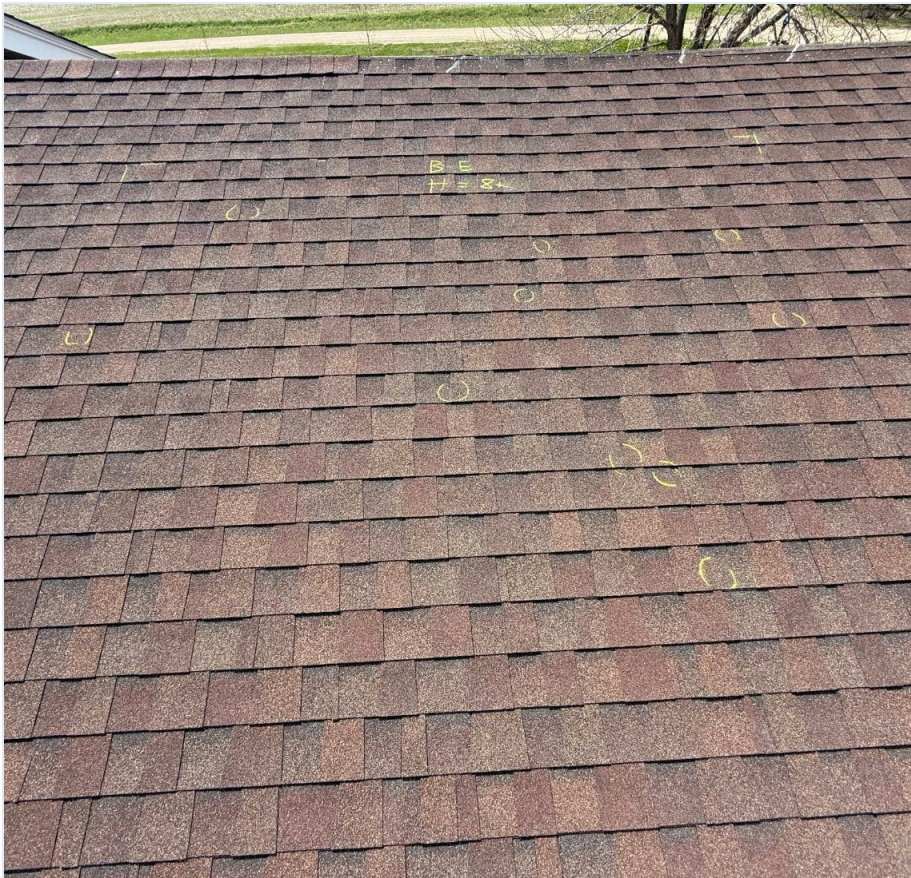
PHOTO 1 OF 17

Back Slope

Extensive hail damage was found to the shingles in the back slope test area.

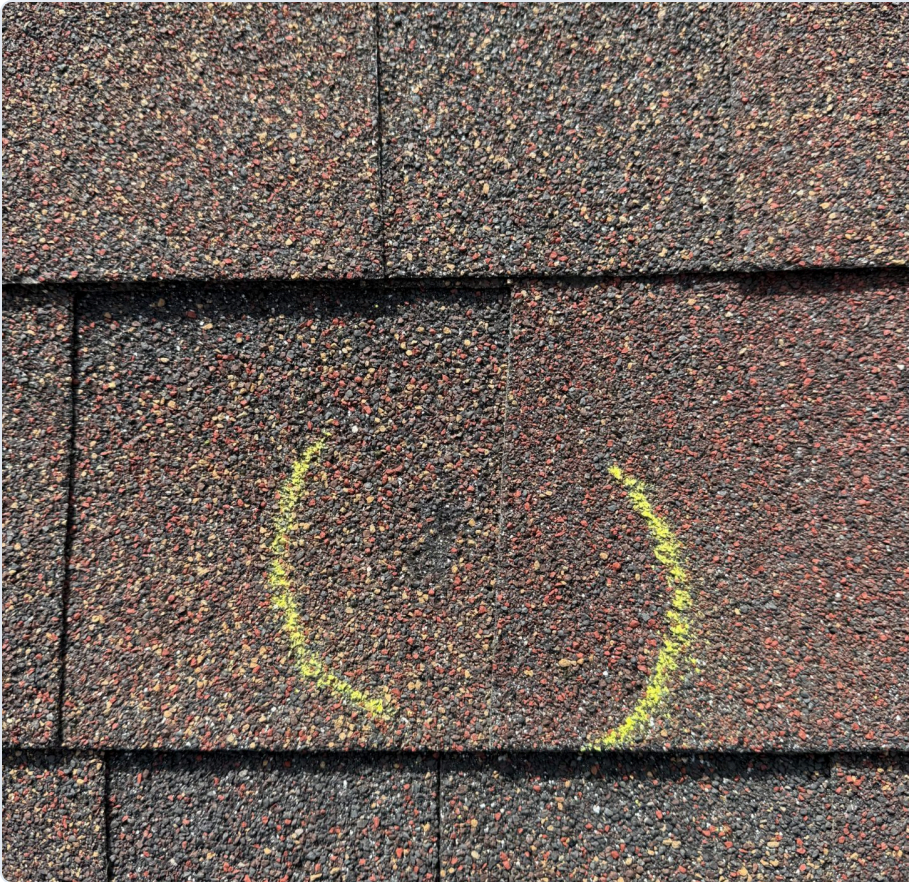
PHOTO 2 OF 17

Back Slope

Extensive hail damage was found to the shingles in the back slope test area.

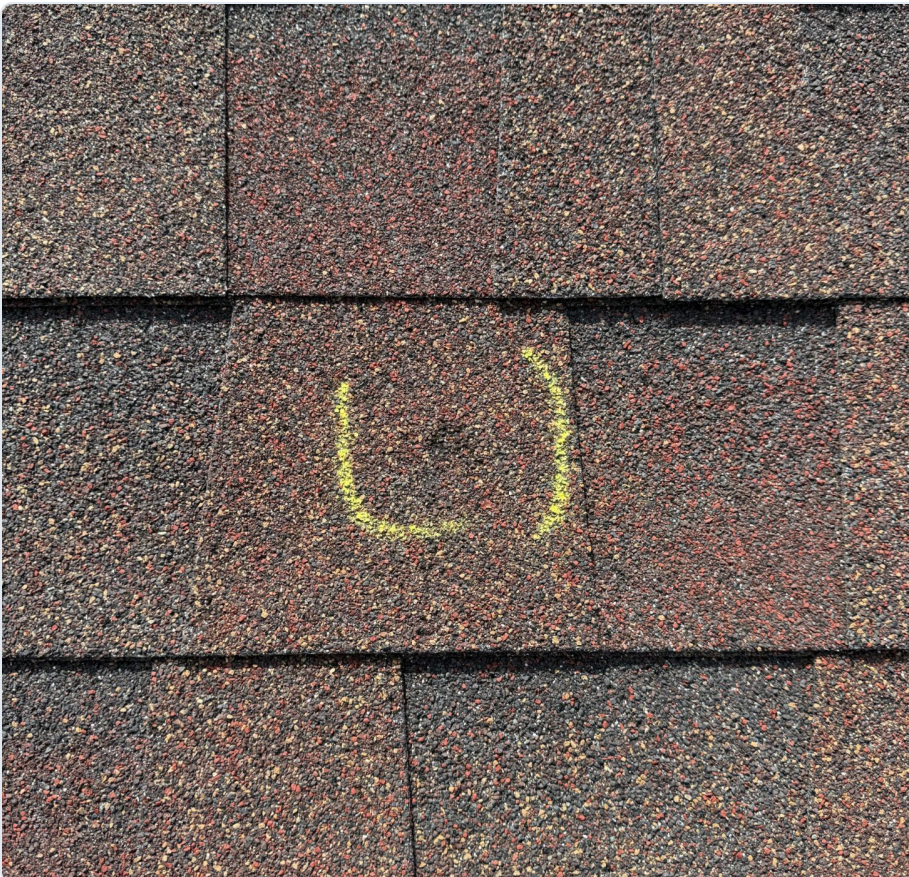
PHOTO 3 OF 17

Back Slope

Extensive hail damage was found to the shingles in the back slope test area.

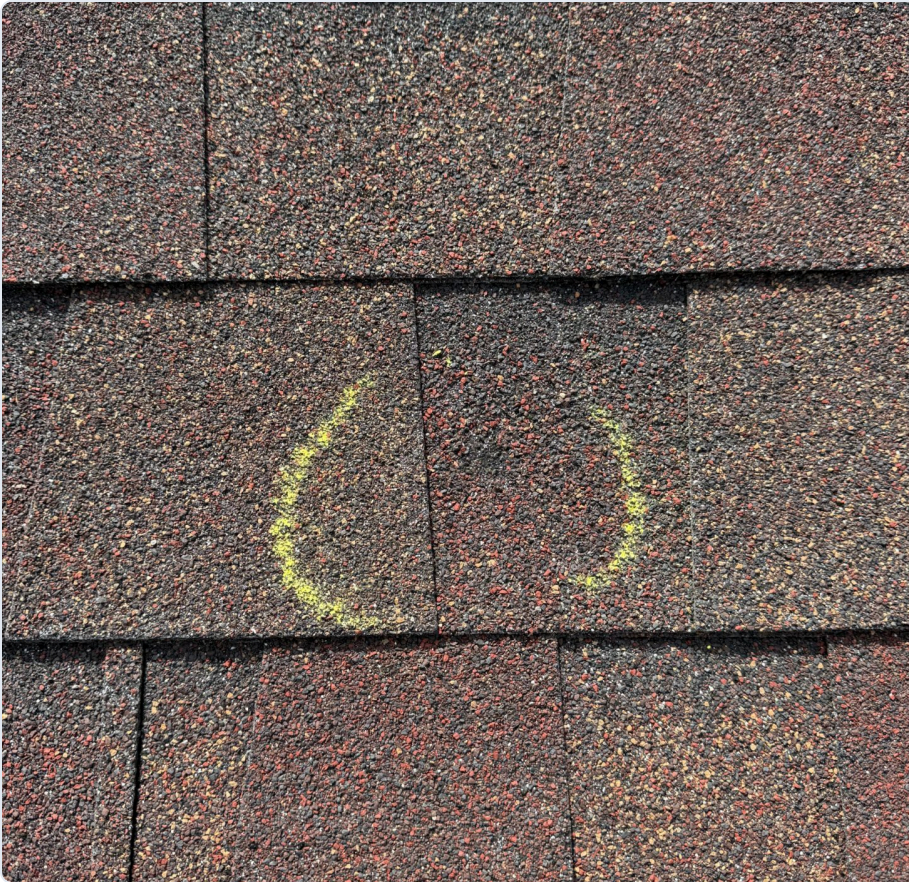
PHOTO 4 OF 17

Back Slope

Extensive hail damage was found to the shingles in the back slope test area.

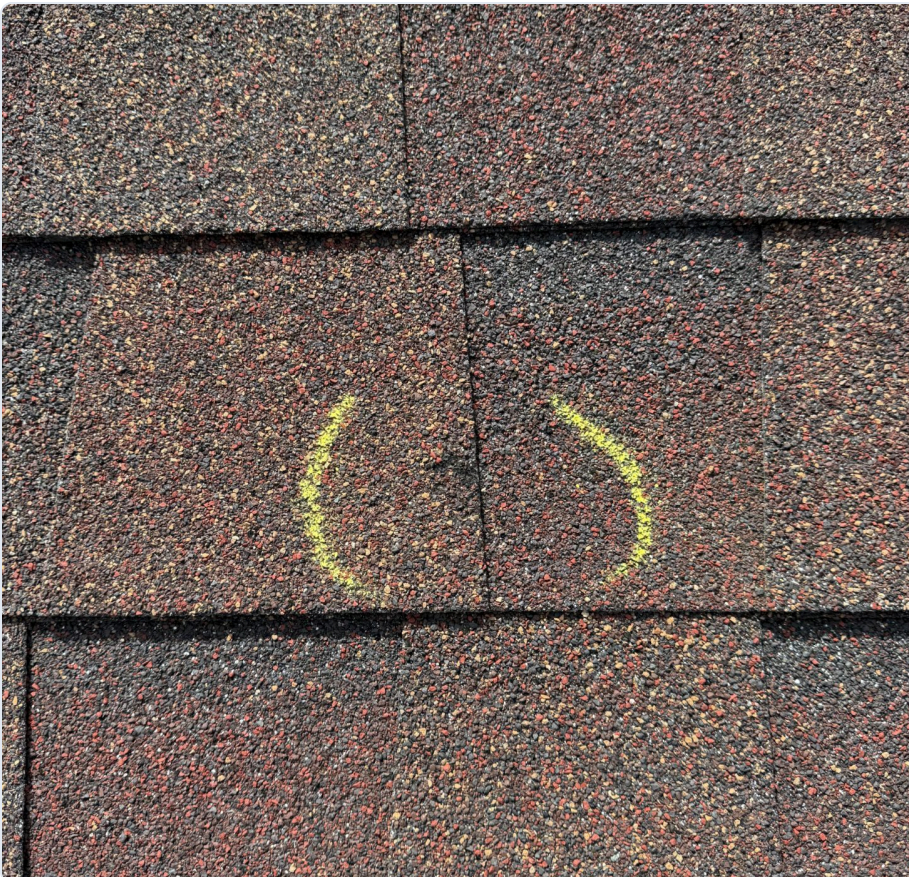
PHOTO 5 OF 17

Back Slope

Extensive hail damage was found to the shingles in the back slope test area.

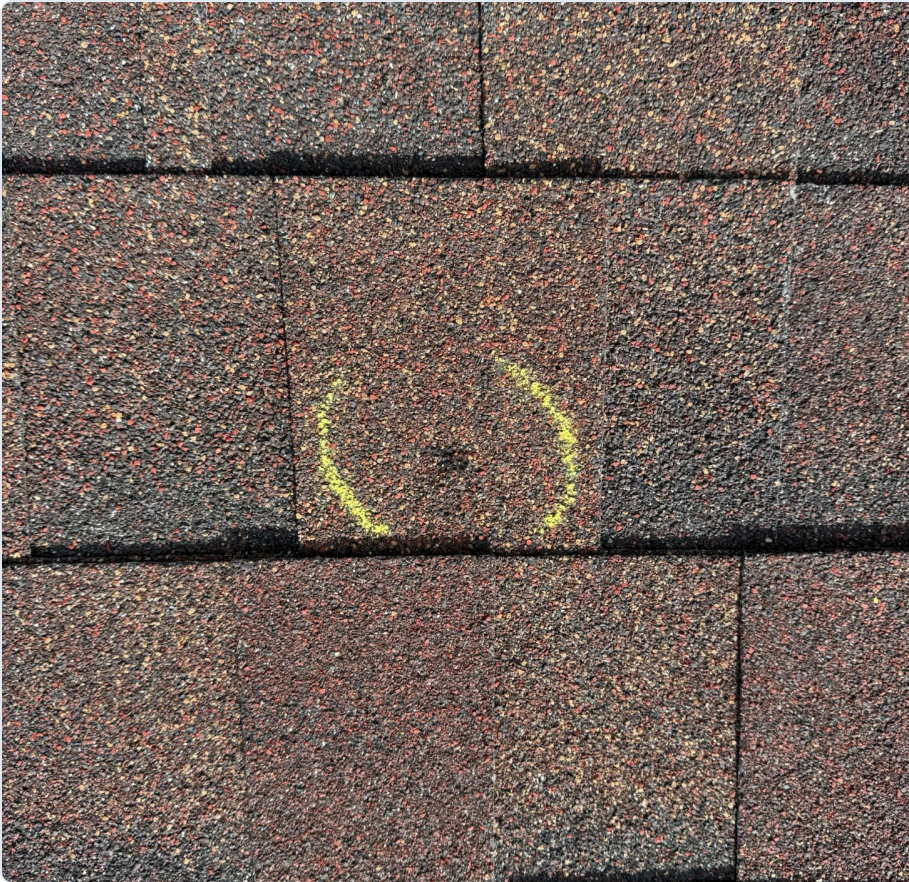
PHOTO 6 OF 17

Back Slope

Extensive hail damage was found to the shingles in the back slope test area.

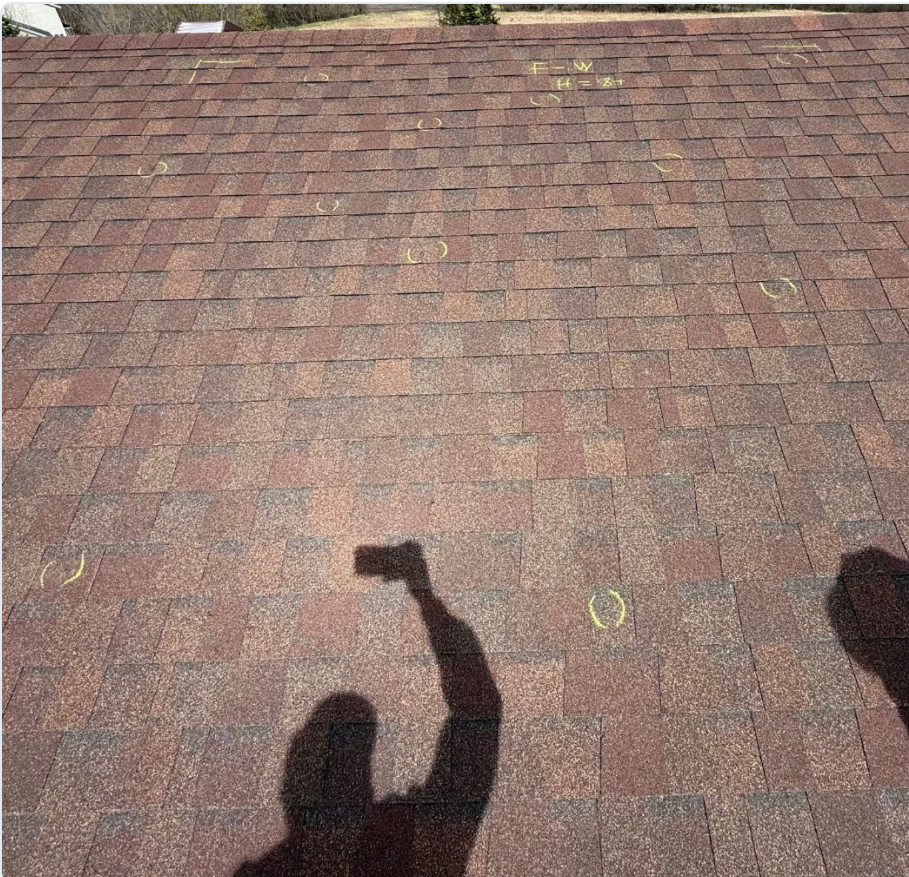
PHOTO 7 OF 17

Front Slope

Extensive hail damage was found to the shingles in the front slope test area.

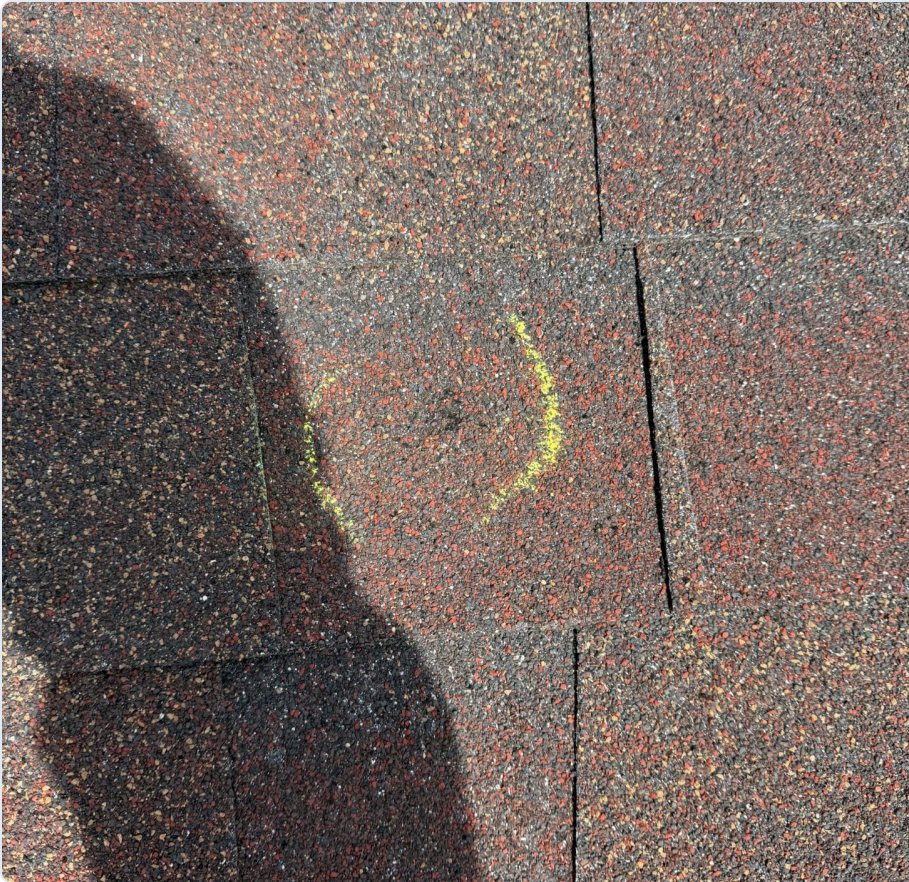
PHOTO 8 OF 17

Front Slope

Extensive hail damage was found to the shingles in the front slope test area.

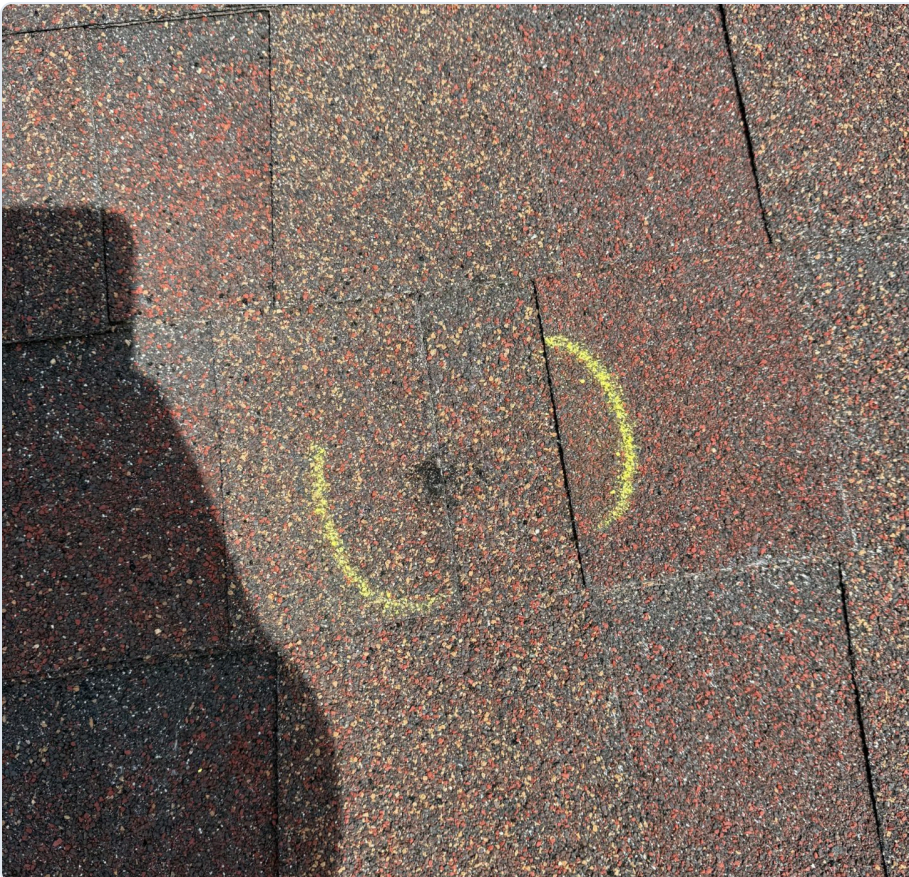
PHOTO 9 OF 17

Front Slope

Extensive hail damage was found to the shingles in the front slope test area.

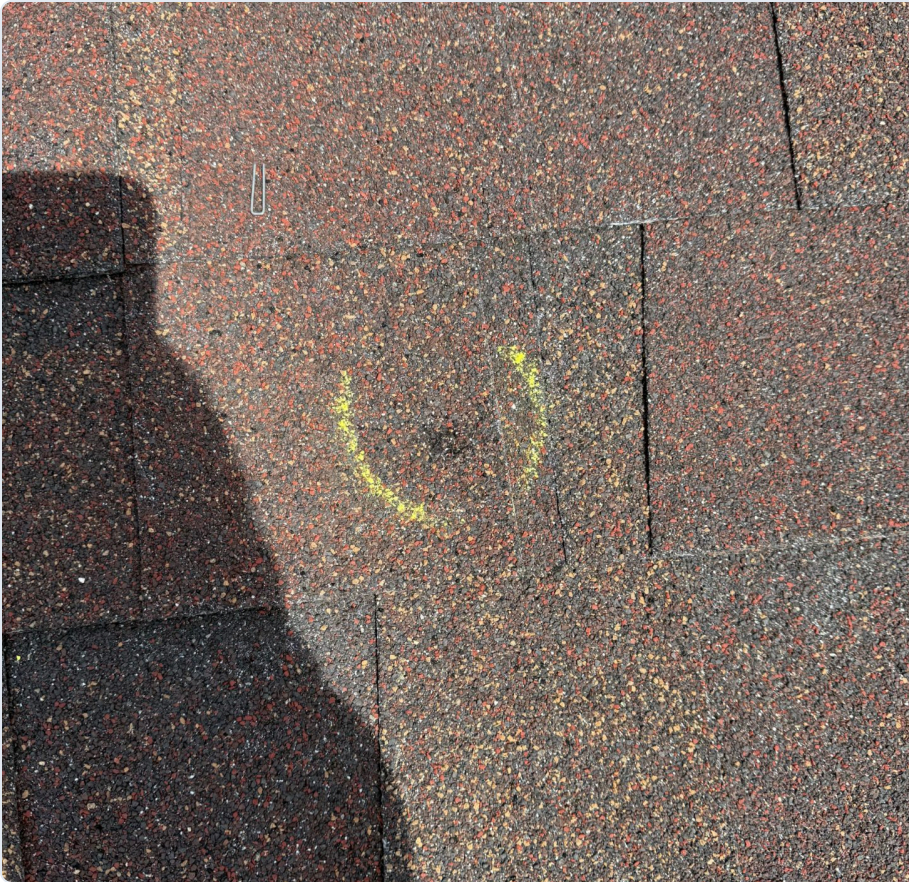
PHOTO 10 OF 17

Front Slope

Extensive hail damage was found to the shingles in the front slope test area.

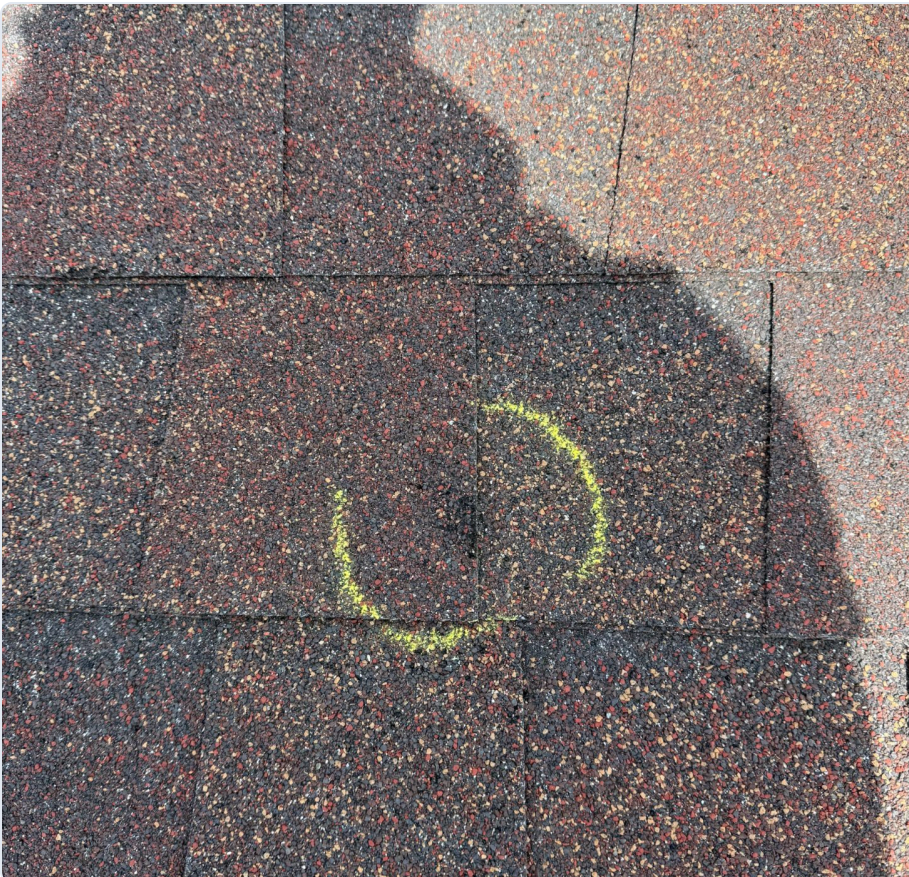
PHOTO 11 OF 17

Front Slope

Extensive hail damage was found to the shingles in the front slope test area.

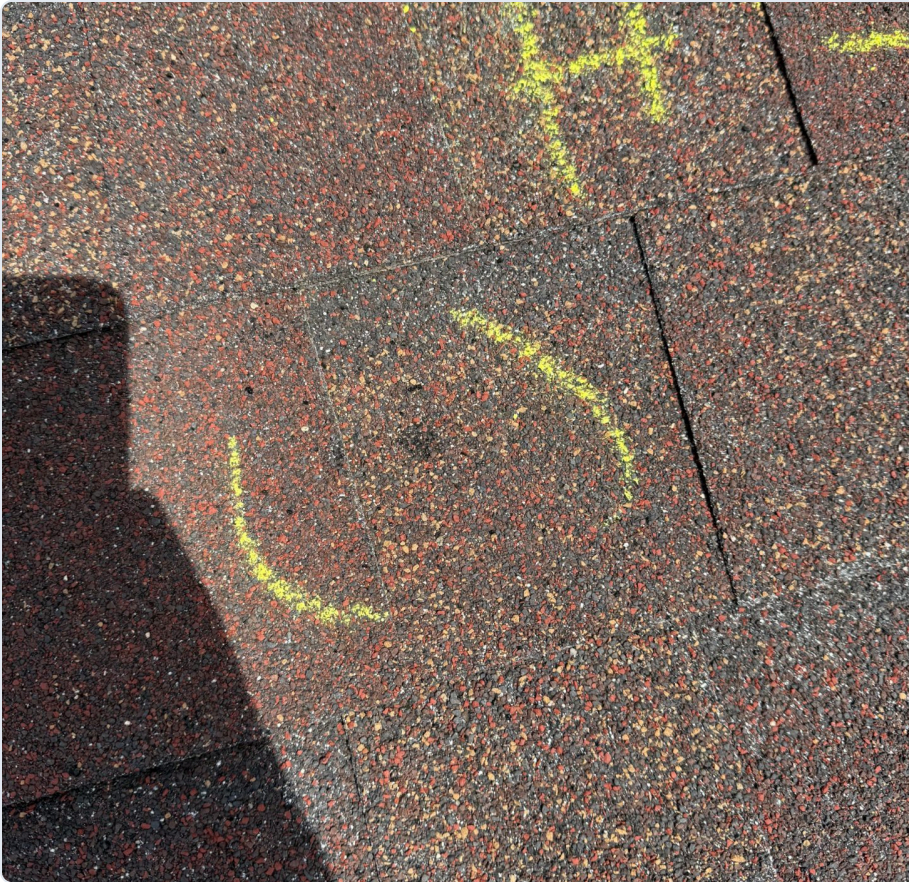
PHOTO 12 OF 17

Front Slope

Extensive hail damage was found to the shingles in the front slope test area.

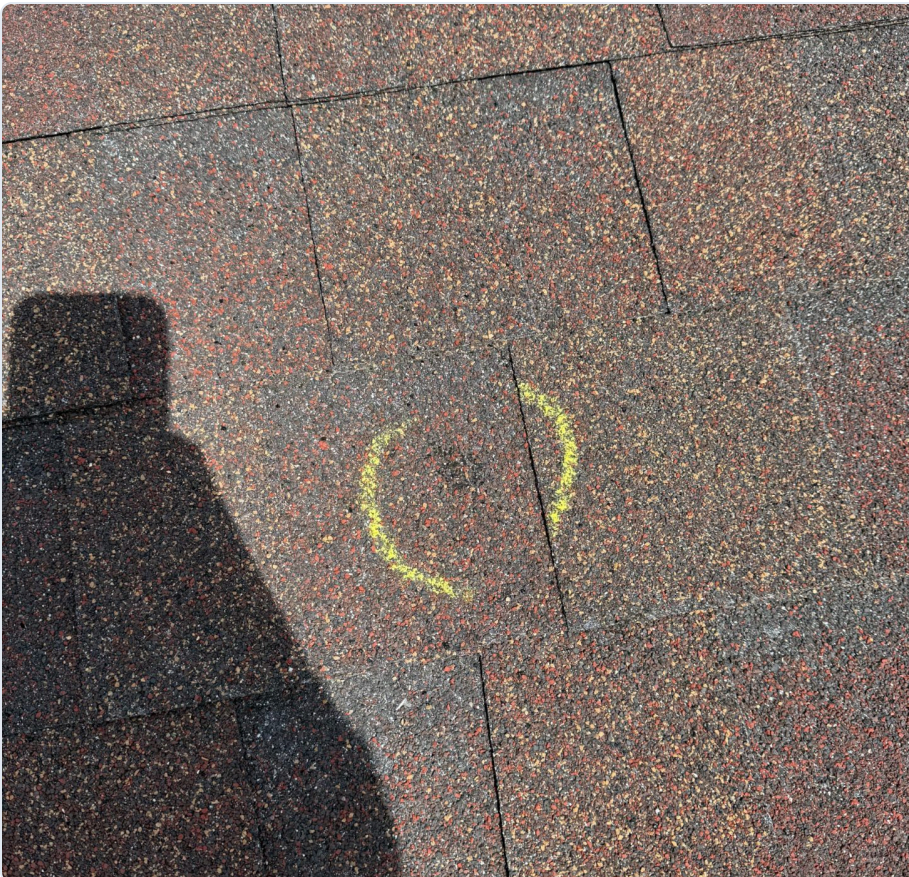
PHOTO 13 OF 17

Front Slope

Extensive hail damage was found to the shingles in the front slope test area.

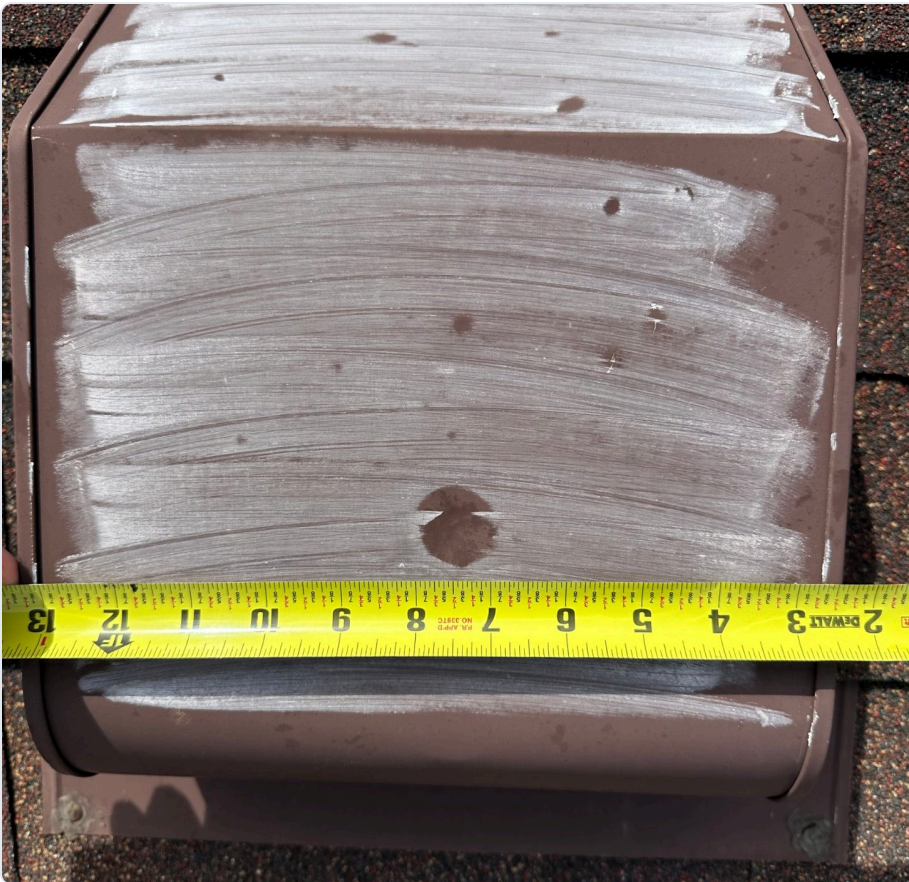
PHOTO 14 OF 17

Roof Vents

Hail damage was noted to the metal roof vents.

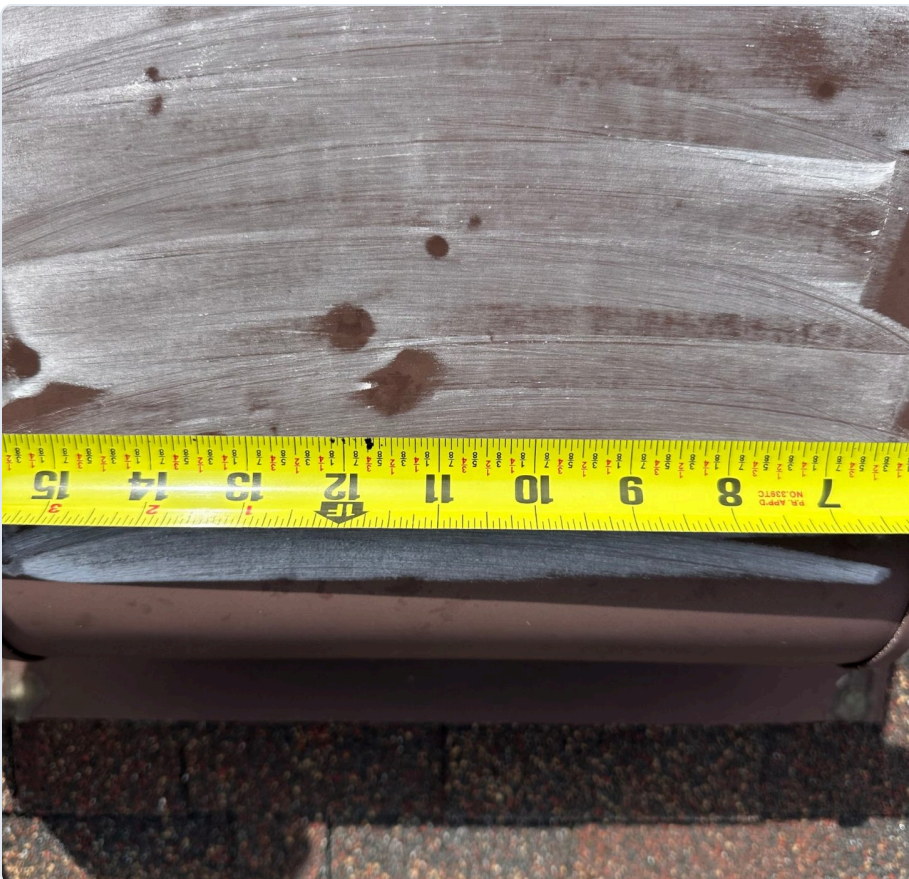
PHOTO 15 OF 17

Roof Vents

Hail damage was noted to the metal roof vents.

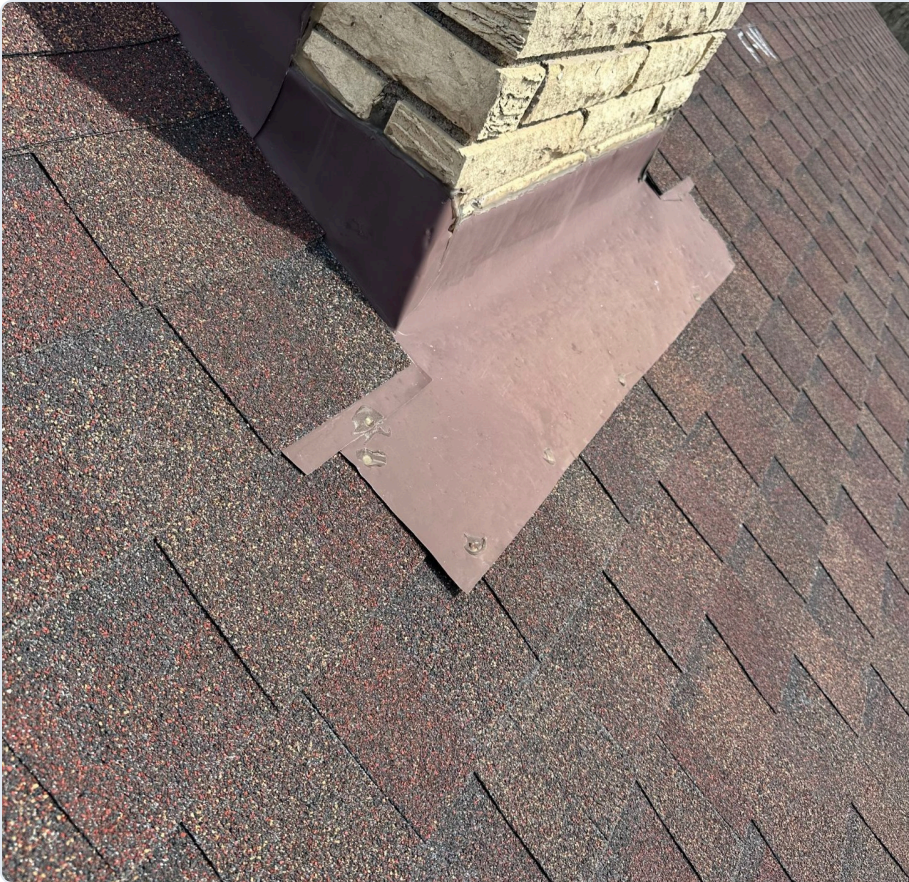
PHOTO 16 OF 17

Chimney Flashing

Hail damage was noted to the chimney flashing.

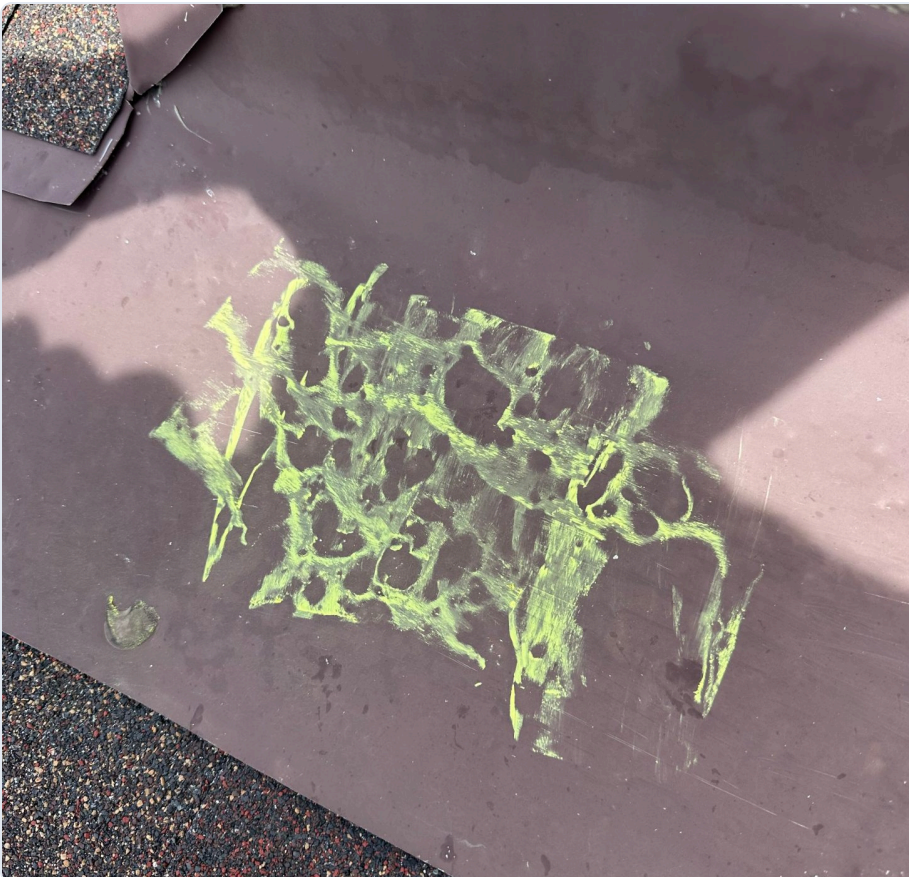
PHOTO 17 OF 17

Chimney Flashing

Hail damage was noted to the chimney flashing.
